# UNDERWATER BRIDGE INSPECTION REPORT

STRUCTURE NO. 7150

BLUE EARTH RIVER

MINNESOTA DEPARTMENT OF TRANSPORTATION  
UNDERWATER BRIDGE INSPECTION

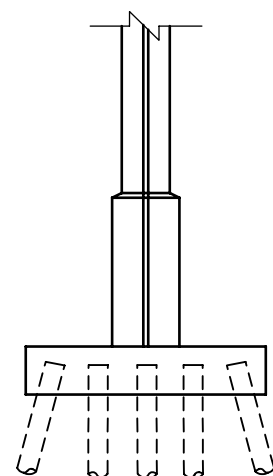
**INSPECTION AND SOUNDING PLAN**

- A scour depression, 2 feet in radius and 1.5 feet deep, was observed at the upstream nose of Pier 1.
- An area of section loss, 1.5 feet wide by 6 inches high with a penetration of 1/8 inch, was observed 1.5 feet below the waterline on the south face of the upstream end of Pier 1.

- An area of section loss, 10 inches wide by 1.5 feet high with a penetration of 1 inch, was observed at the waterline on the downstream nose of Pier 1.

- A scour depression, 5 feet in radius and 1.5 feet deep, was observed at the upstream nose of Pier 2.
- The footing was exposed along the north face of Pier 2 with 2 inches of vertical face exposure detected.

- A light accumulation of 6-inch-diameter timber debris was scattered on the channel bottom around Pier 1.
- A moderate accumulation of timber debris, up to 1 foot in diameter, was observed at the upstream end of Pier 2 and extending along the north face.

Monitor the timber debris and if found to be increasing in the future, removal operations may become warranted to prevent any adverse affects on the bridge.
